The Cleanable VP Shunt Illustrations: Clinical Images

The aim of this paper is to illustrate the proposed idea by Mr. Abdulwahab Alahmari in the paper entitled “Proposal of a Cleanable VP Shunt for Hydrocephalus” 1. This illustration will highlight the invention’s important details and illustrate the fundamental parts of the proposed VP shunt see (Fig. 1 thru 8).

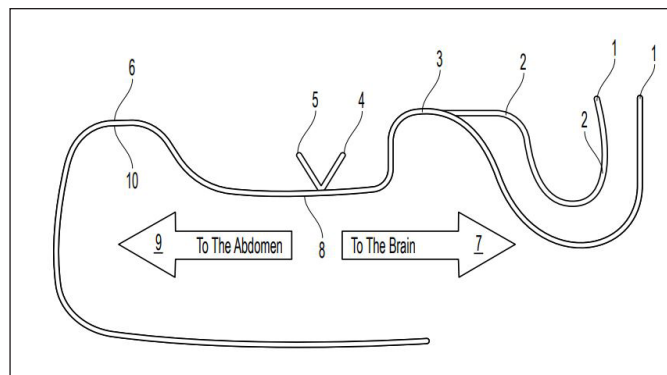
Figure 1. Illustration of the cleanable VP shunt. 1. Entering points, 2. Siphon shaped catheter, 3. Stainless steel catheter, 4. Cleaning access to the abdomen, 5. Cleaning access to the head, 6. PMMA covers the catheter from outside, 7. To the brain catheter, 8. One direction valve, 9. To the abdomen catheter, and 10. PMMA covers the catheter from inside.

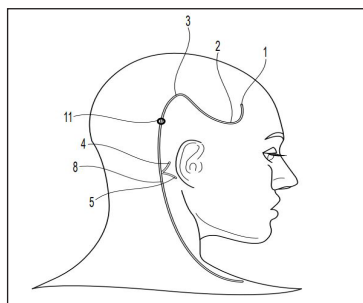
Figure 2. The cleanable VP shunt in situ. 1. Entering points, 2. Siphon shaped catheter, 3. Stainless steel catheter, 4. Cleaning access to the abdomen, 5. Cleaning access to the head, 8. One direction valve, and 11. Fixation to the patient’s skull to prevent malposition.

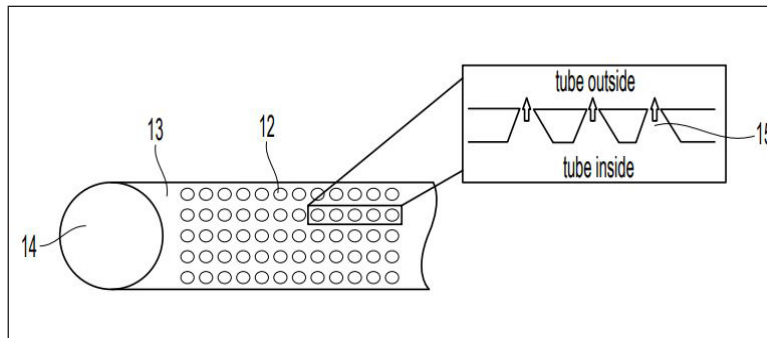
Figure 3. The distal part of the abdominal part of the shunt. 12. Secondary openings to allow the flow from inside to outside, 13. The distal end, 14. The primary opening at the end of the catheter, and 15. The secondary openings are designed (convergence) to allow the flow from inside the shunt to outside the shunt and it prevent the flow back.

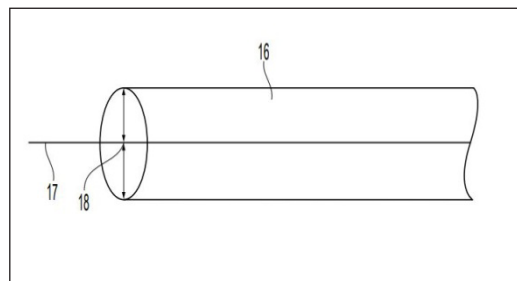
Figure 4. The cleaning wire thru cleaning access. The cleaning wire must have a mark that the neurosurgeon should not pass this mark. 16. Cleaning access, 17. Cleaning wire, and 18. The red mark on the wire where the neurosurgeon should not pass it.

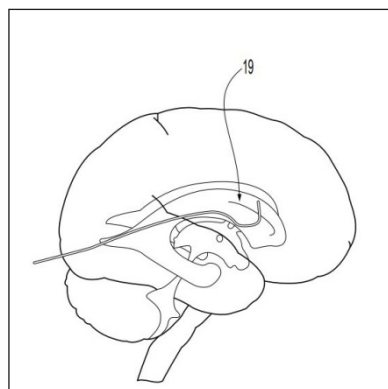
Figure 5. The required position from the neurosurgeon to place the shunt in a superior position as seen in this illustration. 19. The shunt position allows the entrance point to be in a superior position.

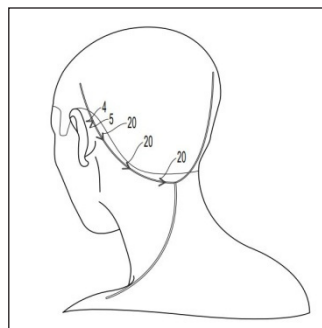
Figure 6. Fixation of the shunt to the skull to prevent any malposition. 4. Cleaning access to the abdomen, 5. Cleaning access to the head, and 20. Fixation of the VP shunt to the patient's skull.

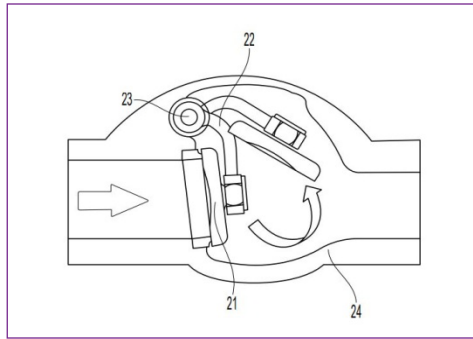
Figure 7. One way valve located in the abdominal part of the VP shunt. 21. Gatekeeper pushed by pressure and it prevents any flow back from the abdomen, 22. Arm, 23. Joint to keep the valve closed with low pressure, and 24. The wall of the valve.

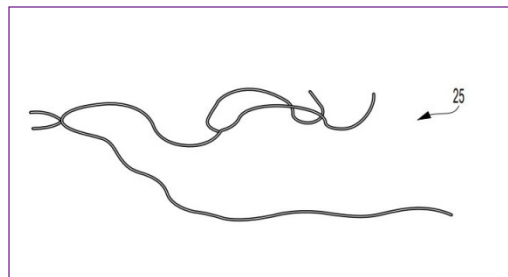
Figure 8. An illustration of the shunt. 25. The entire shunt.
